# Stamping tools for UHSS get tougher

## New automotive materials force tool material to shift into high gear

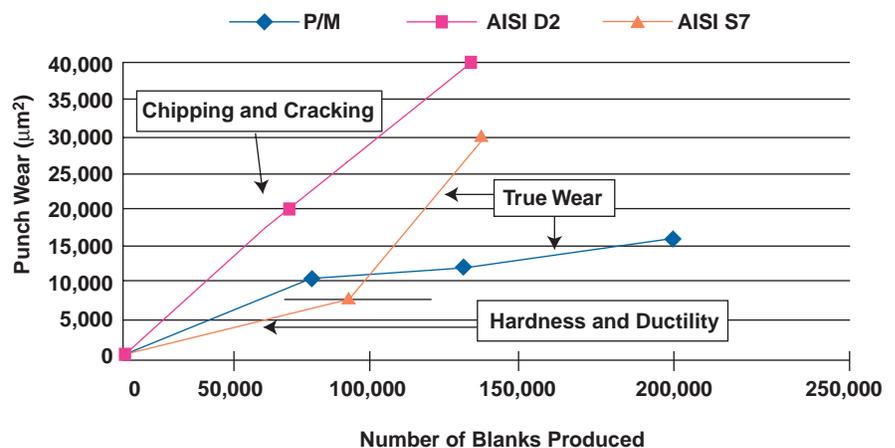
Figure 2

The amount of wear is calculated as the material lost as a function of area in  $\mu\text{m}^2$ . A wear baseline for mild carbon steels (500-600 MPa) is approximately 1,000-4,000  $\mu\text{m}^2$ .

The first set of test results compare the wear on each of the punches after stamping 1,400-MPa work material (see Figure 2). These results were compared to previous tests performed on mild carbon steels. The data showed that the wear rate was higher for UHSS (1,400 MPa) than mild carbon steels (500 to 600 MPa). For UHSS the wear rate was 16,000 to 40,000  $\mu\text{m}^2$  and for mild carbon steels the wear rate was 1,000 to 4,000  $\mu\text{m}^2$ .

The punch made of AISI D2 showed the wear characteristics—chipping and cracking—that correspond to adhesive wear. The AISI D2's low ductility is the likely reason for the excessive wear on the punch. In addition, the low-ductility properties can be linked to excessive wear because wear testing (pin-on-disk) performed on AISI D2 and other tool steels showed AISI D2 had slightly lower wear resistance than the other tool steels. Therefore, it can be concluded that the blanking test showed adhesive wear caused the material loss and wear on AISI D2.

The limits of AISI S7 during this test were at about 100,000 blanked parts; then failure occurred because of excessive abrasive wear (which is common with AISI S7).

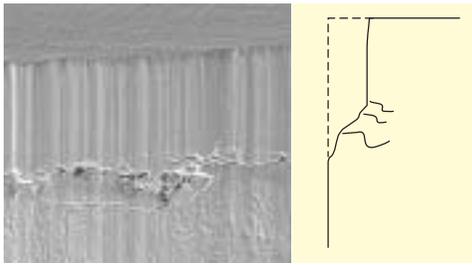
Figure 3

The side and cross section of a test punch constructed of AISI S7 shows excessive abrasive wear.

A close look at the wear mechanisms present at 140,000 blanks for each punch showed that AISI S7 exhibited excessive abrasive wear resulting from friction between the tool and UHSS work material, because of the large amount of material worn away, and chipping and cracking started at the shoulder (see Figure 3).

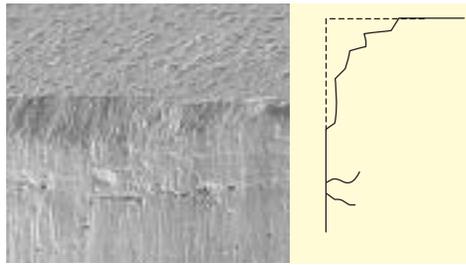
Figure 4

The side and cross section of a test punch constructed of AISI D2 shows excessive chipping and cracking, indicating adhesive wear.

The AISI D2 punch side and cross section showed excessive wear with chip-

ping and cracking occurring on the punch edge and side (see **Figure 4**), causing material loss.

This testing indicated that AISI D2 does not have the ductility required to withstand 140,000-part blanking of UHSS without suffering from large amounts of chipping and cracking, and that AISI S7 does not have the tensile strength required to withstand 140,000-part blanking of UHSS without exhibiting abrasive wear. The tooling material best-suited for blanking automotive structural and exterior components from UHSS must combine a high degree of toughness with good abrasive wear resistance.

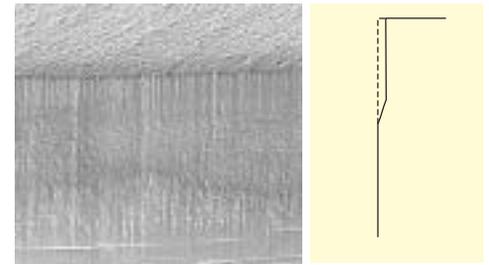
Figure 5

At 140,000 blanks, the punch constructed of a proprietary, third-generation P/M tool steel shows only abrasive wear with no chipping or cracking. No change in appearance of the wear surface was noticed at 200,000 blanked parts.

At 140,000 blanked parts, the punch constructed of the P/M tool steel did not show any chipping or cracking; the only wear mechanism was uniform abrasive wear.

**Figure 5** shows the wear on the proprietary, third-generation P/M tool steel punch after 140,000 blanked parts. Because the material ductility had not been exceeded, abrasive wear was the only wear mechanism present. No change in appearance of the wear surface showed even at 200,000 blanked parts.
